Case Study:

ScaleFix SSD-E Extends Service Life of Pump Rods and Tubing for Major Bakken Operator

Successful single treatment reduces sulfate scale and NORM avoiding replacement of rods and tubing resulting in net savings of \$70K for the operator

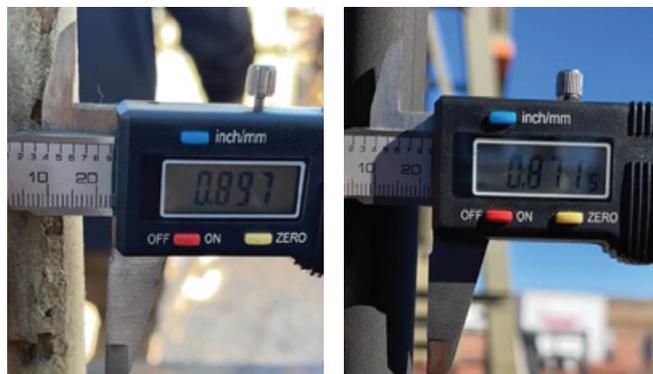
Figure 1 OD measurements taken before and after treatment

The amount of scale removed was evaluated comparing rod ODs and NORM readings before and after treatment. Result was that an average of 0.024" of BaSO₄ scale equating to 558 lbs was removed from the rod string OD and the NORM level had been reduced from 350 µR/hr to 30 µR/hr. There was no

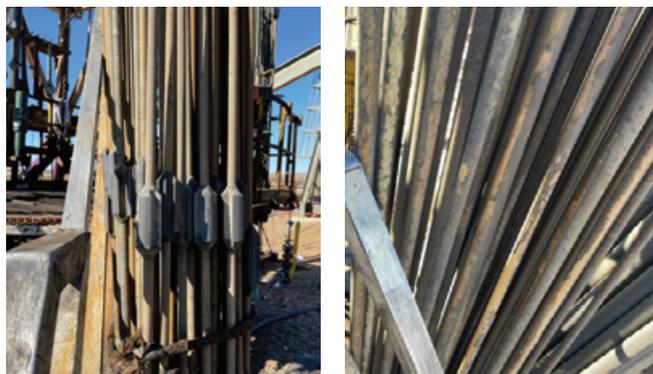
Figure 2 Operator side Pre (left) NORM 237 µR/hr. Post (right) NORM 29-62 µR/hr: after time to dry
