## Case Study:

# SwellRight Side Pocket Mandrel Plug seals damaged mandrel bore for North Sea operator

SwellRight Side Pocket Mandrel Plug successfully isolates leaking side pocket mandrel for global operator in the North Sea.

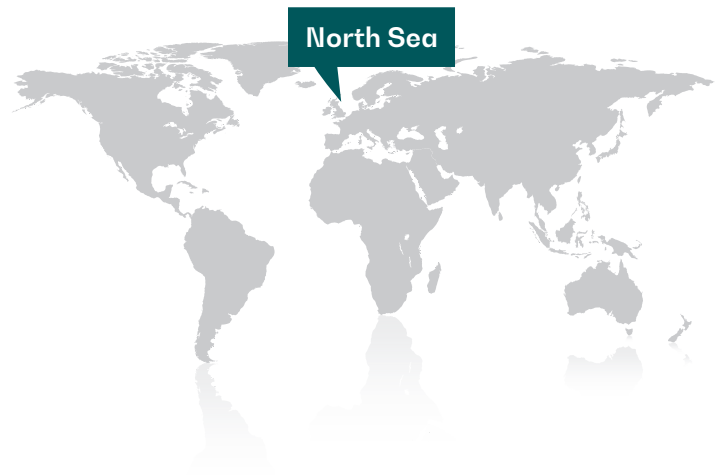
TAQA was asked to provide a sealing solution for a leaking side pocket mandrel. It was essential to provide a solution to avoid the need for an expensive workover to replace the leaking side pocket.

A major North Sea operator required a robust solution to seal a leaking gas lift mandrel and be able to withstand 5000psi. The chevron stack seals were damaged and replacement seals were no longer able to be sealed in the damaged mandrel bore.

TAQA's SwellRight Side Pocket Mandrel Plug was deployed to seal the leaking mandrel bore, proving to be the ideal solution. A dummy valve was wrapped with water swellable rubber capable of sealing in the leaking mandrel bore and

holding 5000psi. The ease of installation and effectiveness of the product was extremely beneficial to the operator as it eliminated the need for intervention, pulling the entire completion to replace the leaking mandrel bore. Not only was it the simplest of solutions, it also reduced the risk factor and the cost of intervention.

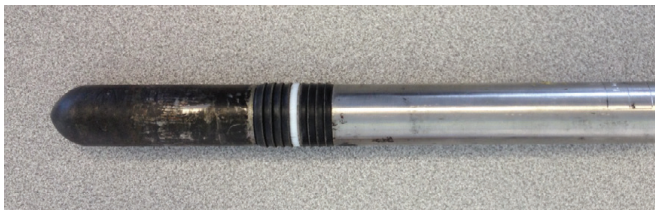
Damaged Gas Lift Valve

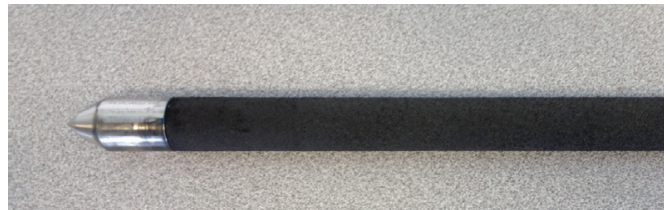
SwellRight Side Pocket Mandrel Plug

TAQA's SwellRight Side Pocket Mandrel Plug successfully isolated the leaking side pocket mandrel, withstanding the required 5000psi, and eliminating the requirement for a workover.
