## Case Study:

# Swellable O-Rings successfully reinstates function of safety valves

Swellable O-Rings help to get wells back on production successfully and faster by sealing badly damaged sealbores.

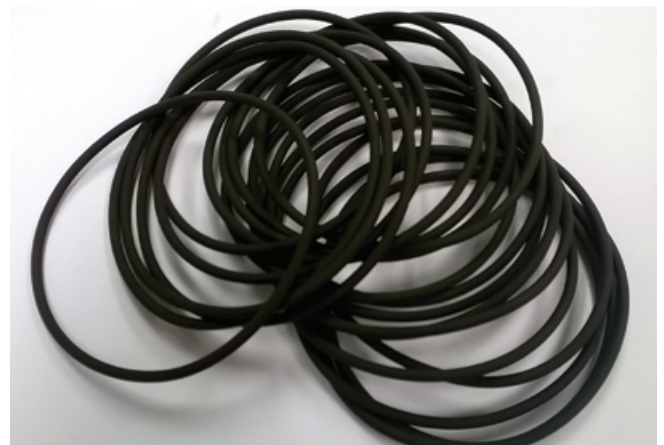
O-rings

TAQA expanded their knowledge on swellable products to come up with the swellable O-ring. The O-ring replaced the existing male to male adaptor in the packing stack. Using the control fluid as well as the wellbore fluid, they swelled the rubber into the scored or damaged sealbore. This created a pressure tight seal to enable full opening pressure to the safety valve and restoring the well to production, saving time and cost on previous operations.
