Case Study:

Swellable O-Rings successfully reinstates function of safety valves

Swellable O-Rings help to get wells back on production successfully and faster by sealing badly damaged sealbores.

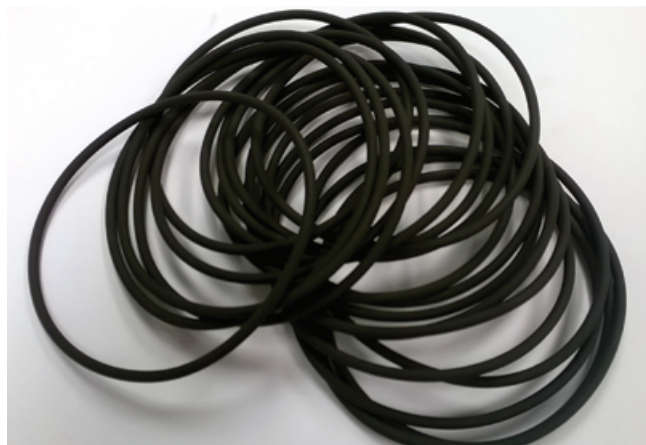
O-rings

TAQA expanded their knowledge on swellable products to come up with the swellable O-ring. The O-ring replaced the existing male to male adaptor in the packing stack. Using the control fluid as well as the wellbore fluid, they swelled the rubber into the scored or damaged sealbore. This created a pressure tight seal to enable full opening pressure to the safety valve and restoring the well to production, saving time and cost on previous operations.
