Case Study:

SwellRight Side Pocket Mandrel Plug seals damaged mandrel bore for North Sea operator

SwellRight Side Pocket Mandrel Plug successfully isolates leaking side pocket mandrel for global operator in the North Sea.

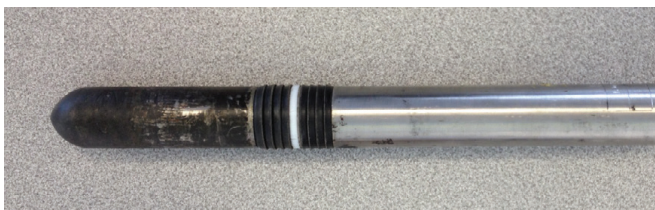
A major North Sea operator required a robust solution to seal a leaking gas lift mandrel and be able to withstand 5000psi. The chevron stack seals were damaged and replacement seals were no longer able to be sealed in the damaged mandrel bore.

Damaged Gas Lift Valve

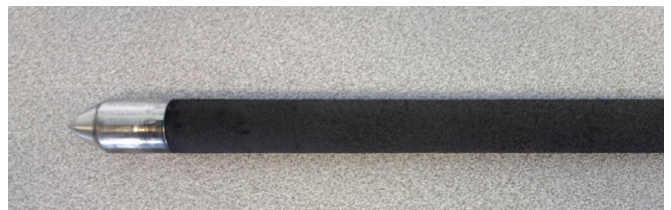
TAQA's SwellRight Side Pocket Mandrel Plug was deployed to seal the leaking mandrel bore, proving to be the ideal solution. A dummy valve was wrapped with water swellable rubber capable of sealing in the leaking mandrel bore and

holding 5000psi. The ease of installation and effectiveness of the product was extremely beneficial to the operator as it eliminated the need for intervention, pulling the entire completion to replace the leaking mandrel bore. Not only was it the simplest of solutions, it also reduced the risk factor and the cost of intervention.

SwellRight Side Pocket Mandrel Plug

TAQA's SwellRight Side Pocket Mandrel Plug successfully isolated the leaking side pocket mandrel, withstanding the required 5000psi, and eliminating the requirement for a workover.
